Hobsons Bay City Council

**Bruce Comben Reserve Future Directions Plan
Draft Report**

December 2010

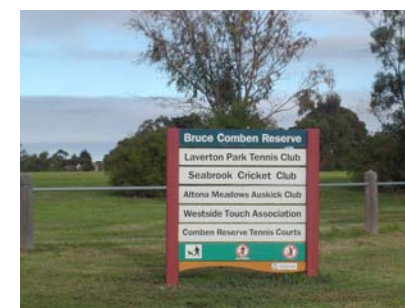
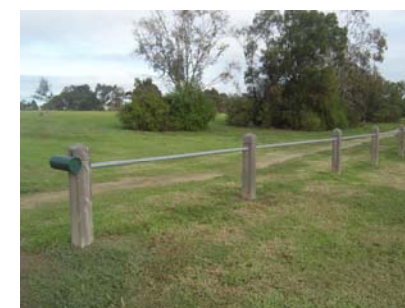
Post and pipe rail fencing is provided along Central Ave, Skehan Bld, MacNeil Dve, Henry Dve and Ascot St Sth. The sections along Central Ave and around the court bowl in Ascot St Sth are relatively new and in good condition. The sections along Skehan Bld, Henry Dve, MacNeil Dve and the remainder Ascot St Sth are older and beginning to deteriorate. Some lengths are leaning, many of the posts are splitting and some have lifted out of the ground.

Timber paling fencing is provided at the back of the houses in Ascot St Sth. The vacant block has wire fencing. The fence is lined by trees and largely hidden from view. The Ravenswood Ct frontage is not fenced.

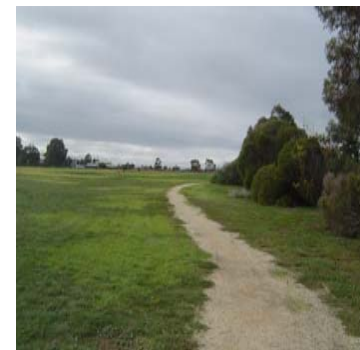
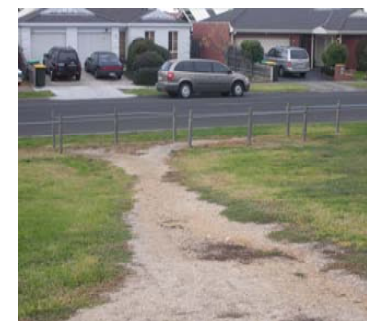
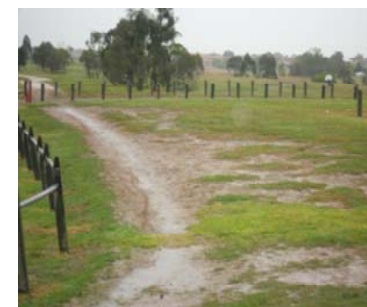
A perimeter granitic sand (pea gravel) pathway extends around the perimeter of the reserve on the north, east and western edges. The pathway is 1.2-1.5 metres wide with a barely visible plinth edge. The eastern section which runs parallel to Henry Dve and Skehan Bld is in poor condition with grass and weeds encroaching the edges and shallow depressions and water furrows in some sections. Some of the links from the path to Skehan Bld are eroded due to the steep gradient. The section running west from the end of Rose St to the pedestrian footbridge has been furrowed by water and the sand has washed down onto the concrete path.

- The gravel and dirt path from the end of the sand path at the corner of MacNeil Dve/Henry Dve to the playground.
- The diagonal dirt path from the same point to the footbridge over Skeleton Creek.
- The dirt path along the southern end of the tennis courts and bowl area.
- The dirt path from the playground, across the back of the pavilion to the sand path near the houses in Ascot St Sth.

These paths are in surprisingly good condition considering their unconstructed nature.

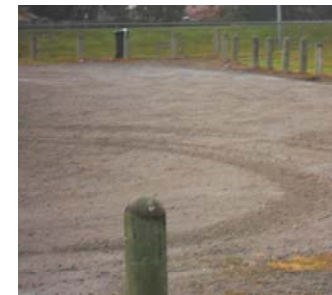
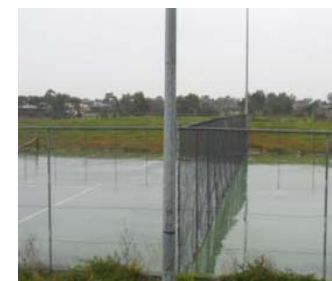
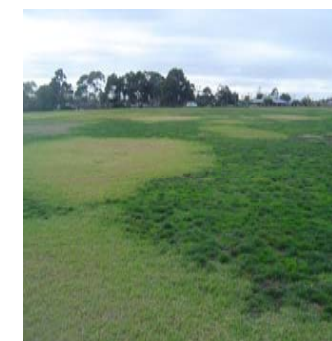
Three carpark areas are provided within the reserve - at the preschool, sporting pavilion and tennis courts. The preschool carpark is in good condition. It is sealed and lit and has 38 car spaces including two disabled bays. The sporting pavilion and tennis carpark are also in good condition. They have gravel surfaces and can accommodate around 45 cars each.

The cricket nets were recently relocated to a new position west of the pavilion adjacent to the gravel car park. The nets are in excellent condition. The former cricket practice area will soon be reinstated as grass.

The bowl area to the west of the tennis courts was originally intended to be netball courts but was used by the former Werribee Council as a place to dump soil. The fill looks reasonably clean but testing may be required to verify this.

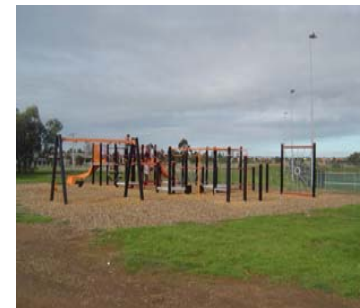
There are two play spaces within the reserve. The main play space is near the pavilion and is of metal frame construction. The equipment was installed over the last six months and incorporates swings, slide, handgrips and climbing apparatus. The second play space is located along Skeleton Creek between Ailsa and Ayr St. The equipment was installed about two years ago and consists of a see-saw and timber fort and climbing apparatus within a mulched fall zone.

The play spaces are in good condition.

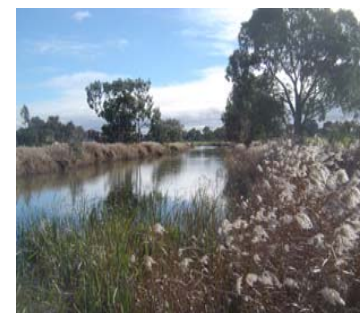
Skeleton Creek serves as a wildlife corridor and habitat link to the coastal reserve of the Cheetham Wetlands and Port Phillip Bay. It is lined with Eucalyptus camaldulensis (River Red Gums) and Phragmite reeds and is the major landscape/environmental feature of the reserve. It was flowing well at the time the assessment was conducted and was clear of litter and other debris.

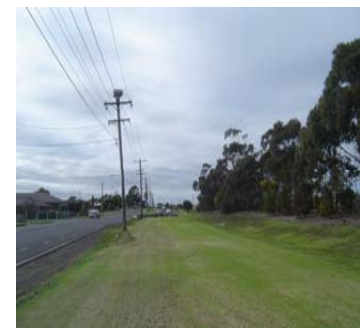
There are many native trees on the Central Ave boundary - established Spotted Gums, Lemon Scented Gums and Yellow Gums. There is a mix of gums with significant stands of Myoporum insulare (Boobialla) on the western edge along Ascot St South. The Acacia baileyana (Cootamundra Wattle) on the Skehan Boulevard frontage have reached senescence.

Elsewhere in the reserve, the trees and shrubs tend to be struggling in the conditions of heavy clay soil and exposure to coastal prevailing winds. Scattered boundary plantings of Acacia implexa (Lightwood), Eucalyptus camaldulensis (River Red Gum), Acacia melanoxylon (Blackwood), Eucalyptus sideroxylon (Ironbark), Allocasuarina littoralis (Black Sheoke) are in generally poor and stunted health.

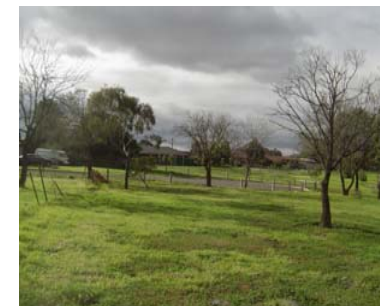
In the reserve's 'western arm' along Skeleton Creek trees and shrubs are varied. There are many River Red Gums along Skeleton Creek and a mix of gums, *Hakea suaveolens* (Hakea) and *Melaleuca armillaris* (Bracelet Honey Myrtle) as group plantings. At Ailsa to Ayr Sts, the mix of Ash and native shrubs are generally in poor condition. A number of shrubs and trees have reached senescence, some have died and/or broken and require replacement.

There is a significant recent planting (approximately 60 trees) of what appear to be Ironbark and River Red Gum between Ascot and Alisa Sts. There is also a good planting in one section of the asphalt path and gravel path interface along Skeleton Creek.

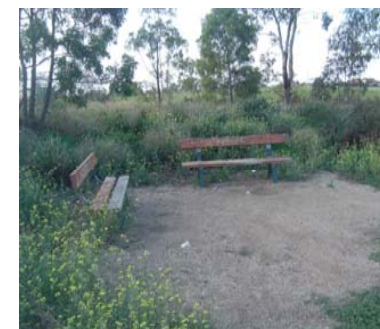
Seating is located along the Skeleton Creek trail, however, all seats are set at an uncomfortable angle to sit on, generally set too low for easy access for adults and in particular for elderly people.

The seating between the tennis courts and the pavilion has no shade provision and two of the four seats have no back rests. Elsewhere no seating is provided. Immediately north of the tennis courts is a relatively new picnic shelter of metal post and roof construction. A table and two independent bench seats make up a picnic table.

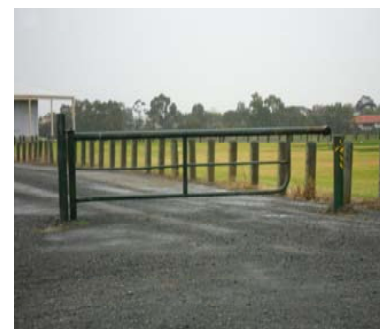
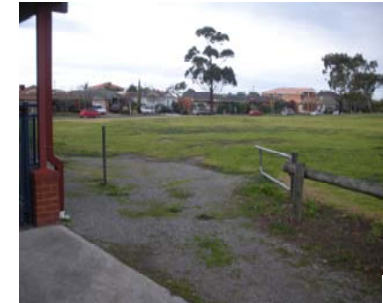
- A gate across the main access road 20 metres from the front entrance
- A gate at the eastern edge of the preschool
- Lights over the preschool carpark and solar light near the footbridge
- Alarm systems in and security lighting off the sports pavilion and preschool
- Bollards and post and log fencing around the carparks and access roads

- The gates are not locked every night
- The tennis courts remained unlocked
- The paths are not lit
- The tennis and sports pavilion carparks are not lit
- The open stormwater drain immediately east of the creek

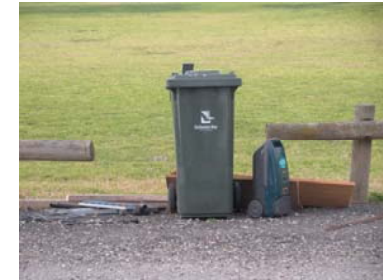
- About seven permanent rubbish bins are located around the park reserve – the majority in the carparks and access roads
- The reserve was just about litter free at the time of the assessment
- There was some graffiti on the footbridge and the pavilion
