<b>Heritage Precinct Name</b>	<b>Spotswood Residential Heritage Precinct</b>
<b>Address</b>	Bolton Street (part), Craig Street (part), Forrest Street (part), George Street, Hope Street (part), Hudsons Road (part), Melbourne Road (part), McLister Street (part), Raleigh Street (part), Reed Street (part), Robb Street (part), Robert Street (part) and The Avenue (part) in Spotswood
<b>Heritage Overlay</b>	<b>HO30</b>
<b>Related Precinct(s)</b>	Not applicable
<b>Significance</b>

## HO30 SPOTSWOOD RESIDENTIAL HERITGE PRECINCT SCHEDULE

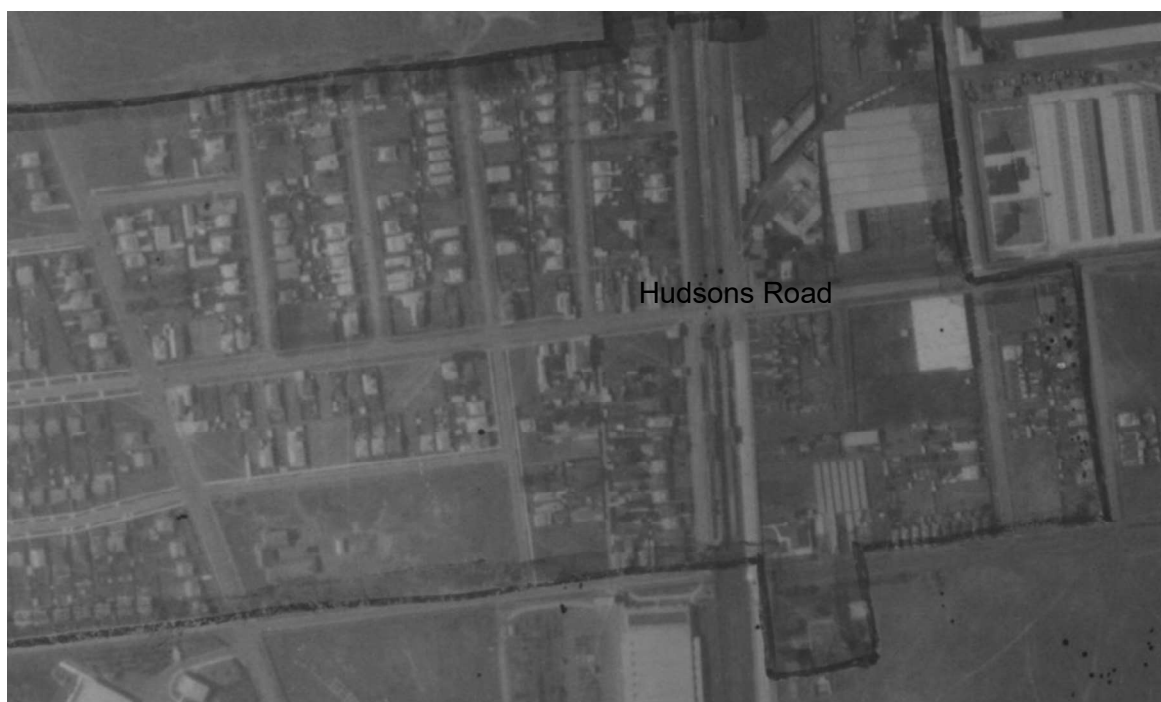
(Source: Landata, Maldon Prison, Run 6, Frame 2874)

Precinct area in 1931

At this time, there was only one house on Craig Street, west of Raleigh Street and no residences to Reed Street, though several were erected in the next ten years. Between 1920 and 1930, several additional houses had also been erected on The Avenue, the western side of both Bolton and George streets, as well as the western end of Hudsons Road.<sup>15</sup> The burgeoning area is evident in the below aerial photograph, taken in 1931.

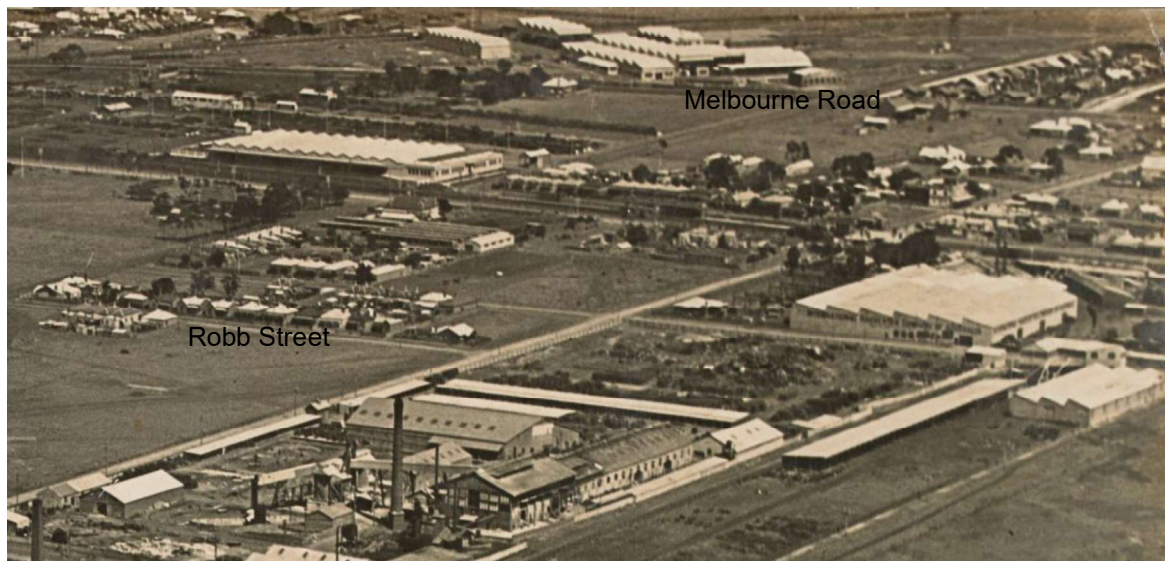
(Source: Aerial view of M.M.B.W. pumping station at Spotswood, Shaw Ross Aviation, Co H29860, SLV)

Southern part of the precinct, between Robb Street and Melbourne Road, in 1930

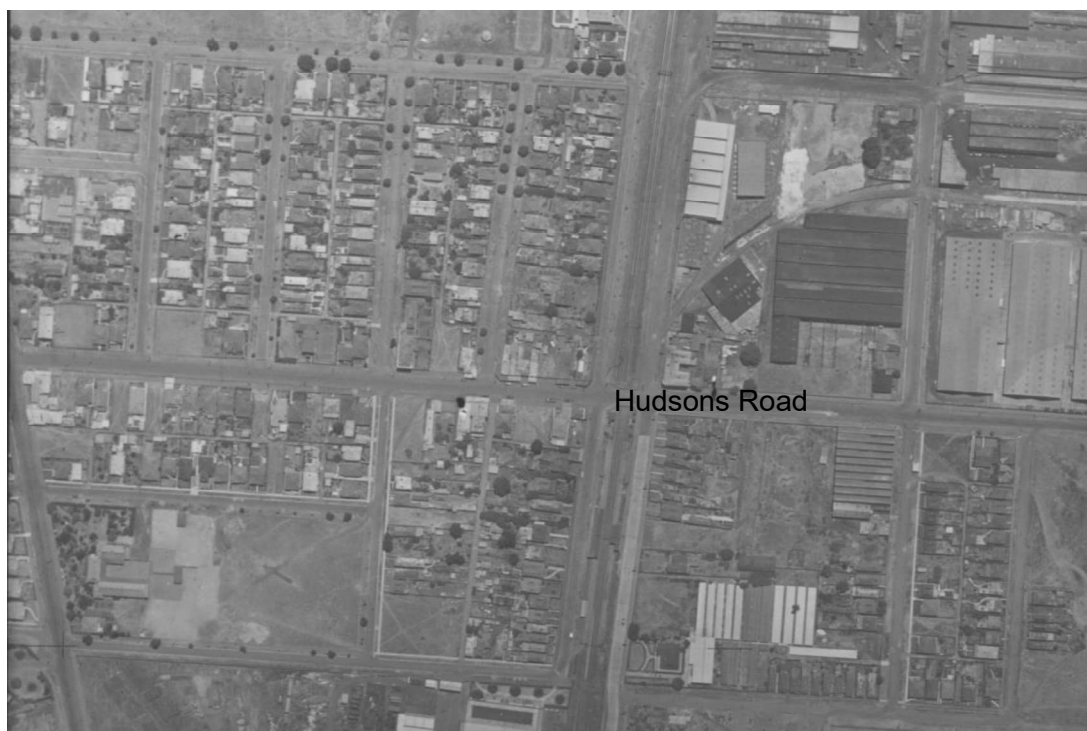
(Source: Melbourne and Metropolitan Area Project, Run 21, Frame 58566, Landata)

Precinct area in 1945

In 1945, there was still several vacant allotments in the Spotswood area, most of which were located to the southern end of Robert Street and the northern side of Hudsons Road (seen on below aerial). By this time, street trees had been planted to George, Bolton and Robert streets as well as the northern side of The Avenue.<sup>16</sup>
