## RE: Precinct 15 Rezoning - Environmental

Council's Precinct 15 "Preliminary Site Assessment and Precinct Remediation Strategy Plan" was prepared during September 2012 to give Council the confidence that the Precinct can accommodate the proposed medium – high residential land use along with public open spaces. In addition, the strategy plan would allow any site contamination issues to be identified at an early stage which could then be given due consideration for the overall design and built form of any development.

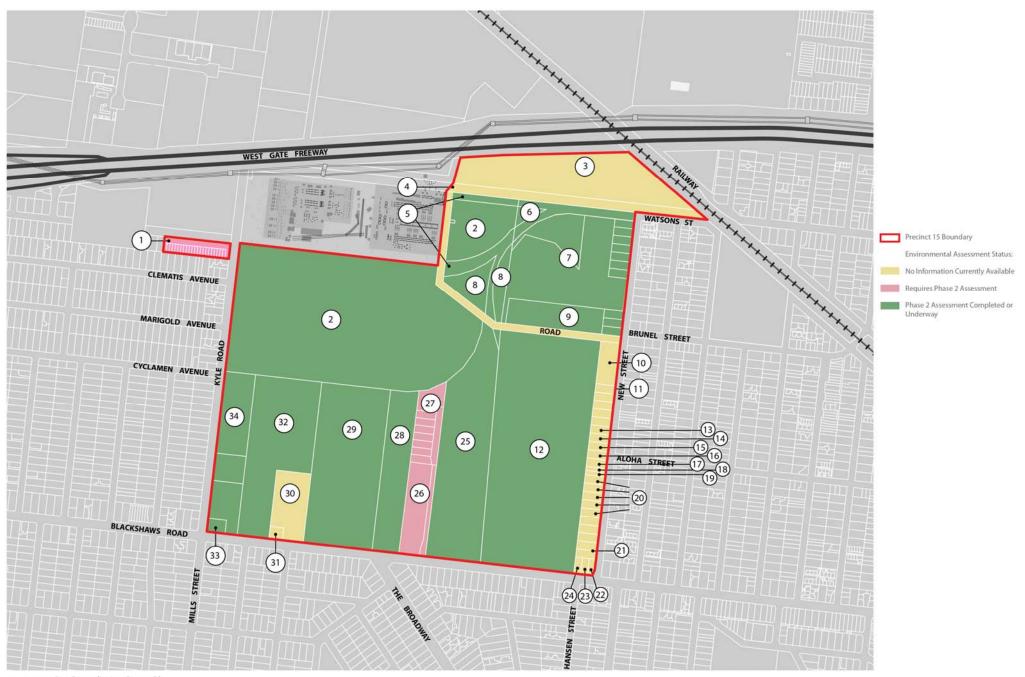
Figure 22 - Site Remediation Status Plan

**Environmental Status Plan**

Most sites have now progressed through the preliminary stages and into detailed site investigations and associated clean-up works to allow for the proposed land uses as presented in the attached Land Use Plan (Attachment II) and the Environmental Status Plan (Attachment III)

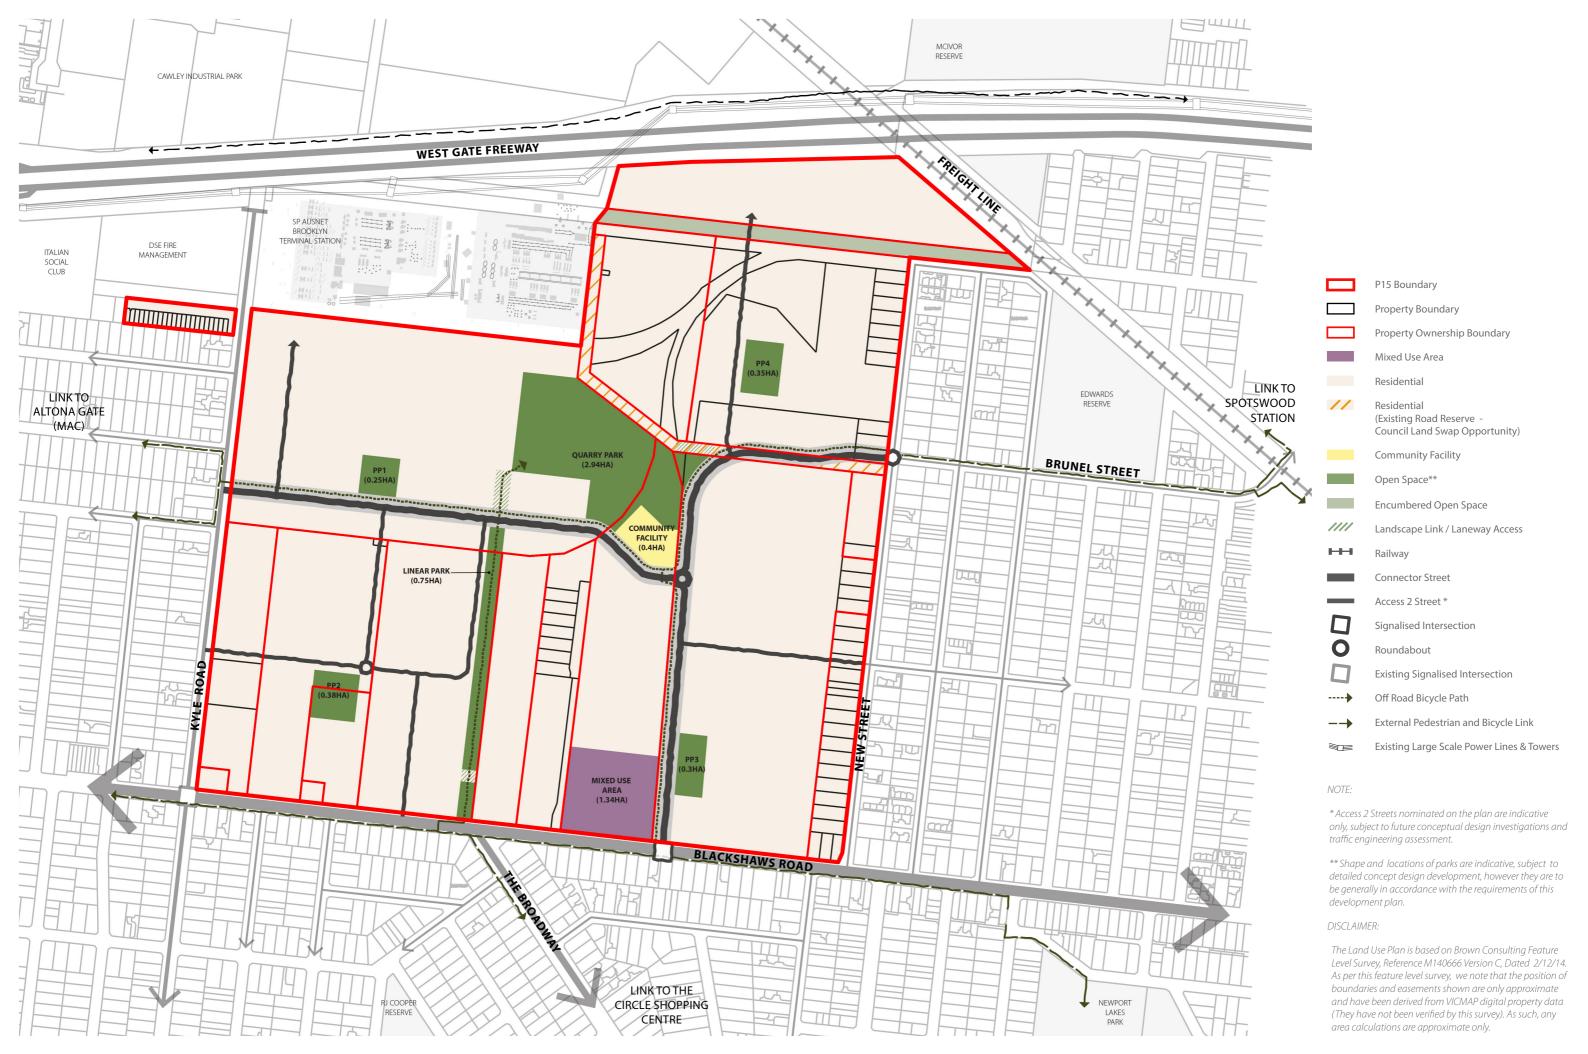
Land Use Plan - Property Ownership Boundaries

**Land Use Plan**
