PAINE RESERVE LANDSCAPE MASTERPLAN

Site Analysis Plan

PREPARED: JUNE 2019 NOT TO SCALE

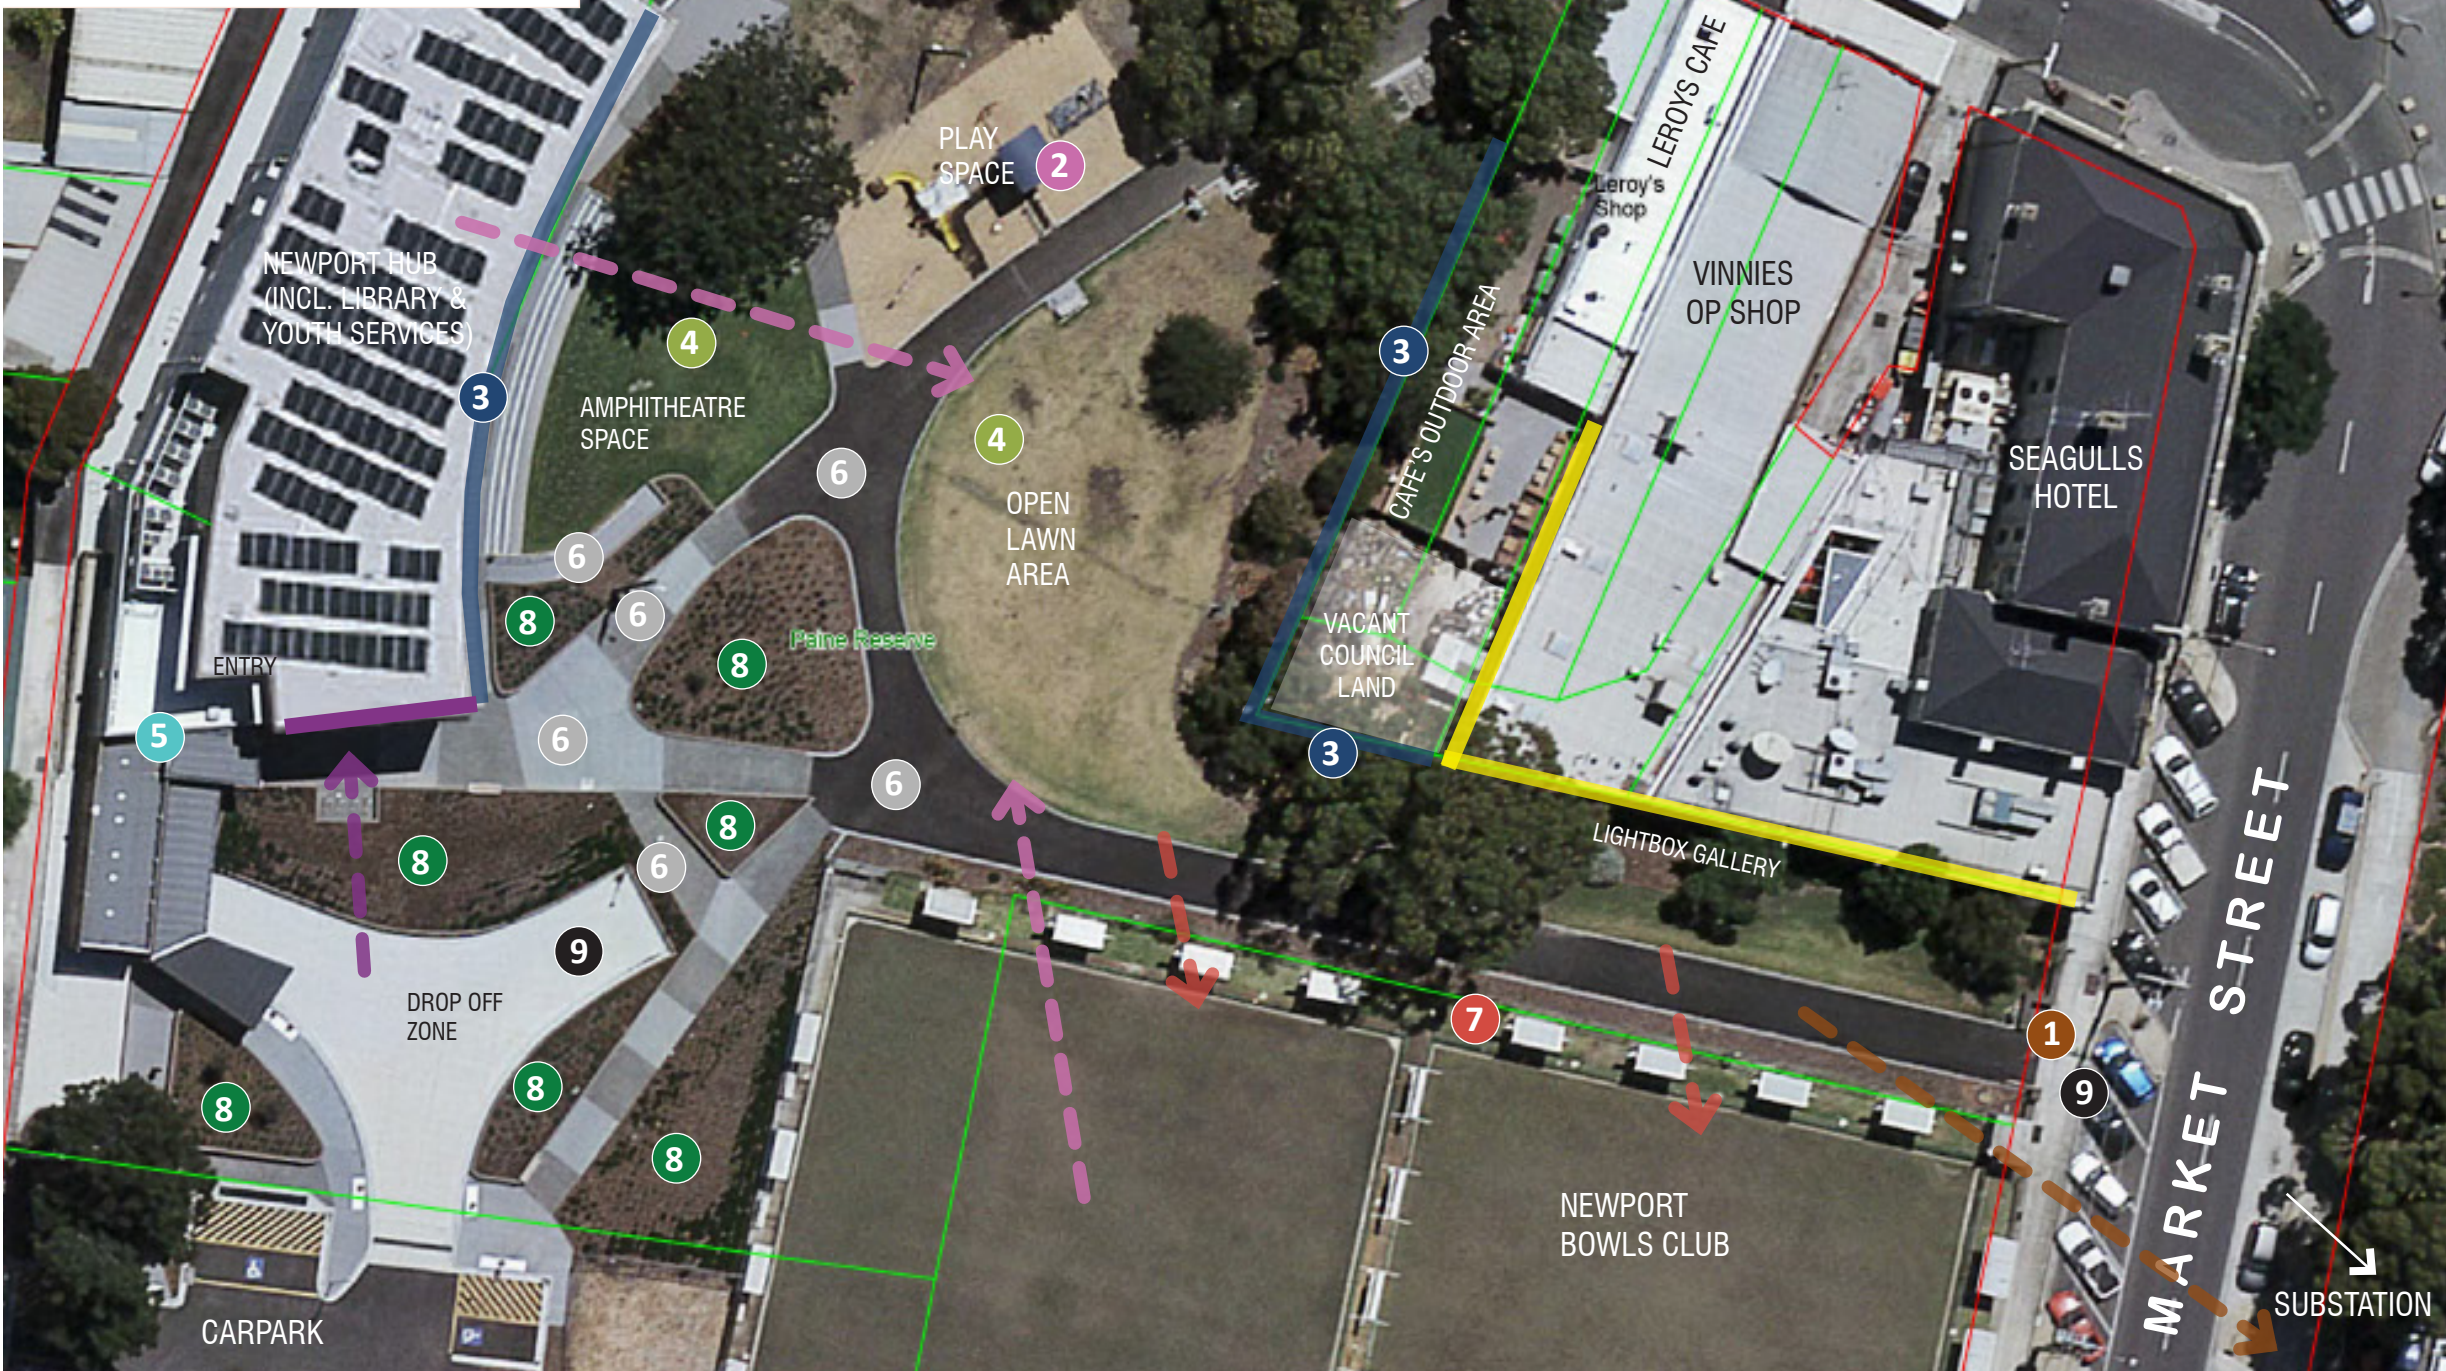
KEY VIEWS:

- ➔ View to the Substation
- HERITAGE building facades
- ➔ Long views into the Park
- ➔ Views into the Bowling Club from the Park - to be retained
- Closed edges/facades
- ➔ View to large blank wall

ISSUES & OPPORTUNITIES:

- 1 Improve the views from the street into the Park.** Currently it's cluttered with street furniture, low walls and poles. There is no strong identity to the main entrances from Market and Mason Street or to Newport itself.

- 2 Create more play opportunities for wider age groups.** The existing play ground caters for younger children only.
- 3 The edges to the Park are closed off** with border garden beds and the Hub appears closed rather than open.

- 4 The lawn areas can be improved.** There is no irrigation in some areas, the amphitheatre lawn has poor drainage and the paths cut through it. Fewer paths would create larger, open lawn areas while framing the edges of the spaces.

- 5 No hierarchy of entrances to the Library/Hub.** There are two but the North entry is the main one. The library wifi extends outside for outdoor study.

- 6 Many hardsurfaces.** There is a lot of under-utilised and excess hardsurfaces particularly the wide junctions of paths, the carpark drop off zone and a ramp duplicating a sloped path.

- 7 Tired bowling club fence.** Views into the greens should be maintained for visual interest and passive surveillance.
- 8 Some of the many raised garden beds take up potential use-able space.** Some are also performing poorly with lack of drainage and are difficult to maintain.

- 9 No access into the park for maintenance vehicles and event set up.**
